**Flood Control Project Maintenance  
Levee Inspections**

## 2019 Channel Summary Report

## Merced Streams Group

**Levee Inspection Report By Mile - Channel 2019**

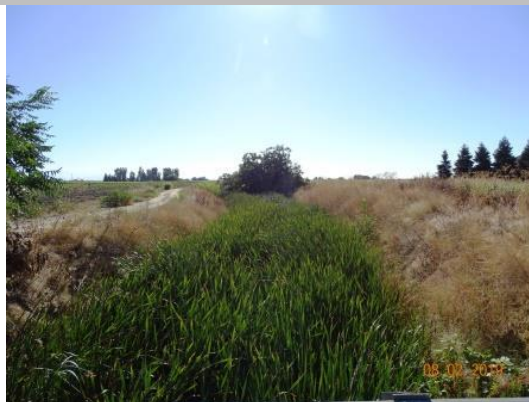
Photo 1 of 2 : CH\_2019\_NA0013\_36\_41\_20190814\_00089.jpg

Rating **	M	Issue No.	41	GPS Lat/Long
Issue Type +	Ma	Location *		37.278630 °
Category	Rivers, Channels & Designated Flood			-120.343030 °
Item	Vegetation & Obstructions			
DWR ID	DWR_NA0013_36_c_2012_41			
Action/Comments				
Inspector Comments: Vegetation in the channel may impede flow and should be cleared.

View of vegetation in the channel. Summer 2019

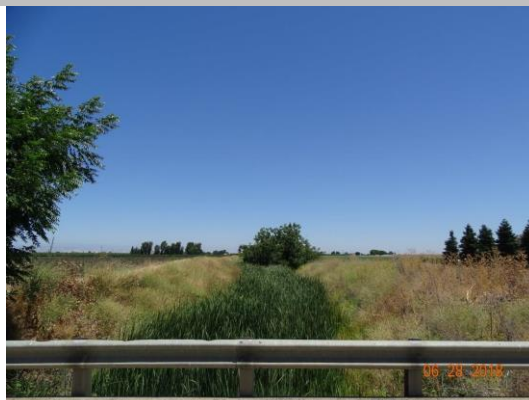
Photo 2 of 2 : CH\_2019\_NA0013\_36\_41\_20190722\_00021.jpg

Inspector Comments: Vegetation in the channel may impede flow and should be cleared.

View of vegetation in the channel. Summer 2018

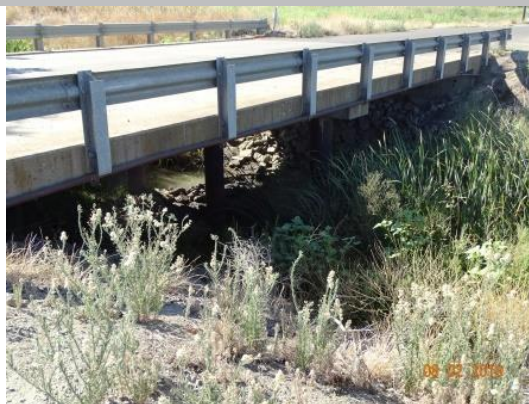
Photo 1 of 1 : CH\_2019\_NA0013\_36\_44\_20190814\_00090.jpg

Rating **	A	Issue No.	44	GPS Lat/Long
Issue Type +	Ma	Location *		37.278696 °
Category	Rivers, Channels & Designated Flood			-120.343030 °
Item	Revetments			
DWR ID	DWR_NA0013_36_c_2012_44			
Action/Comments

View of revetment underneath the bridge. Summer 2019

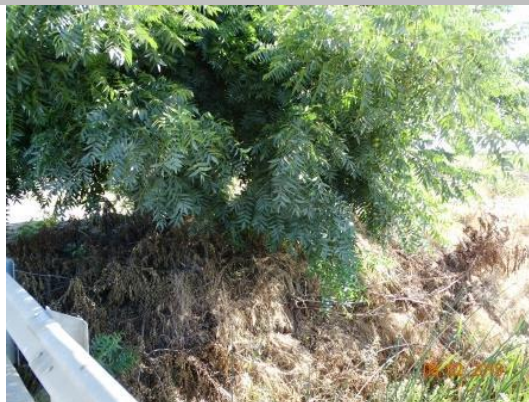
Photo 1 of 1 : CH\_2019\_NA0013\_36\_45\_20190814\_00091.jpg

Rating **	A	Issue No.	45	GPS Lat/Long
Issue Type +	Ma	Location *		37.278696 °
Category	Rivers, Channels & Designated Flood			-120.343030 °
Item	Encroachments			
DWR ID	DWR_NA0013_36_c_2012_45			
Action/Comments				
Inspector Comments: Remove prunings from the right bank.

View of prunings on the right bank. Summer 2019

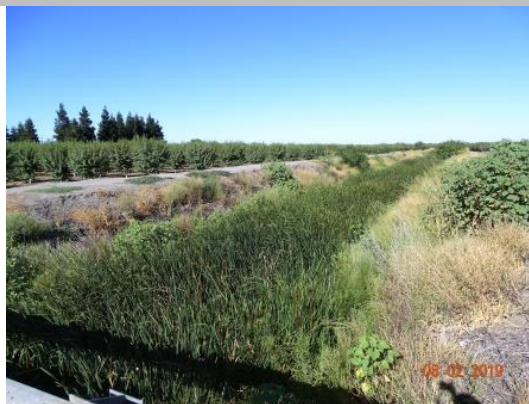
Photo 1 of 2 : CH\_2019\_NA0013\_36\_46\_20190814\_00092.jpg

Rating **	M	Issue No.	46	GPS Lat/Long
Issue Type +	Ma	Location *		37.278696 °
Category	Rivers, Channels & Designated Flood			-120.343030 °
Item	Vegetation & Obstructions			
DWR ID	DWR_NA0013_36_c_2012_46			
Action/Comments

View of vegetation in the channel. Summer 2019

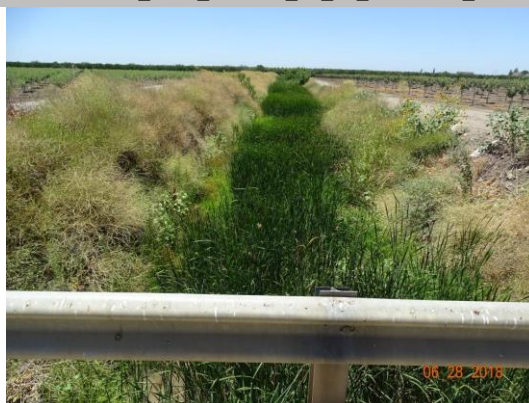
Photo 2 of 2 : CH\_2019\_NA0013\_36\_46\_20190722\_00023.jpg

Rating **	M	Issue No.	46 (cont)	GPS Lat/Long
Issue Type +	Ma	Location *		37.278696 °
Category	Rivers, Channels & Designated Flood			-120.343030 °
Item	Vegetation & Obstructions			
DWR ID	DWR_NA0013_36_c_2012_46			
Action/Comments

View of vegetation in the channel. Summer 2018

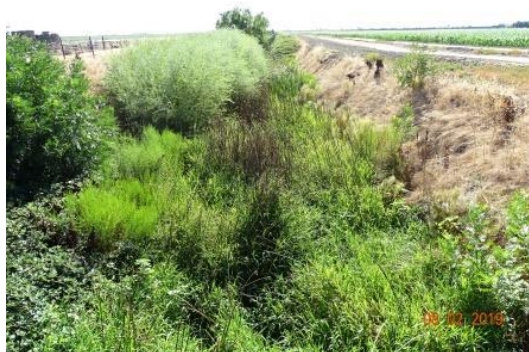
Photo 1 of 2 : CH\_2019\_NA0013\_36\_51\_20190814\_00093.jpg

Inspector Comments: Vegetation in the channel impedes flow and should be cleared.

View of vegetation in the channel. Summer 2019

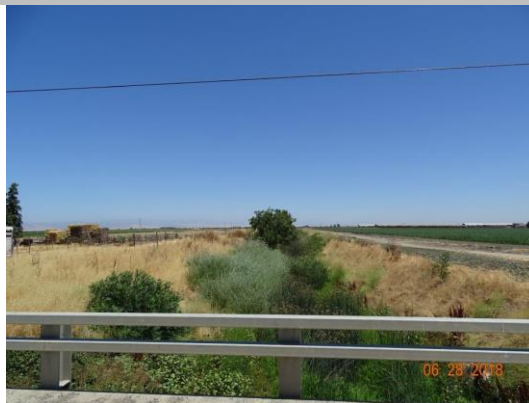
Photo 2 of 2 : CH\_2019\_NA0013\_36\_51\_20190722\_00024.jpg

Rating **	U	Issue No.	<b>51 (cont)</b>	GPS Lat/Long
Issue Type +	Ma	Location *		37.272980 °
Category	Rivers, Channels & Designated Flood			-120.379090 °
Item	Vegetation & Obstructions			
DWR ID	DWR_NA0013_36_c_2012_51

View of vegetation in the channel. Summer 2018

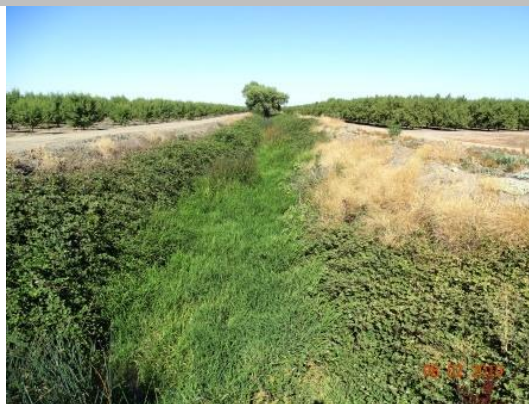
Photo 1 of 2 : CH\_2019\_NA0013\_36\_56\_20190814\_00094.jpg

Rating **	M	Issue No.	56	GPS Lat/Long
Issue Type +	Ma	Location *		37.272980 °
Category	Rivers, Channels & Designated Flood			-120.379090 °
Item	Vegetation & Obstructions			
DWR ID	DWR_NA0013_36_c_2012_56			
Action/Comments				
Inspector Comments: Clear vines that may reduce channel capacity.

View of vegetation in the channel. Summer 2019

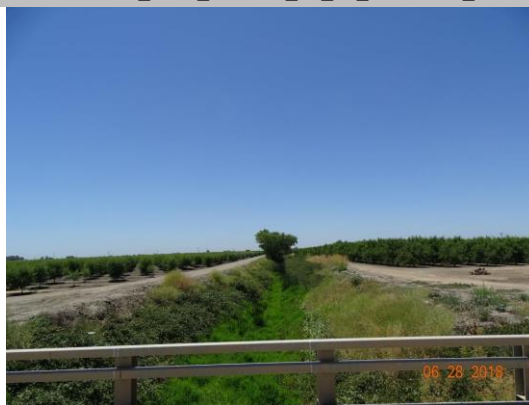
Photo 2 of 2 : CH\_2019\_NA0013\_36\_56\_20190722\_00027.jpg

Rating **	M	Issue No.	<b>56 (cont)</b>	GPS Lat/Long
Issue Type +	Ma	Location *		37.272980 °
Category	Rivers, Channels & Designated Flood			-120.379090 °
Item	Vegetation & Obstructions			
DWR ID	DWR_NA0013_36_c_2012_56

View of vegetation in the channel. Summer 2018

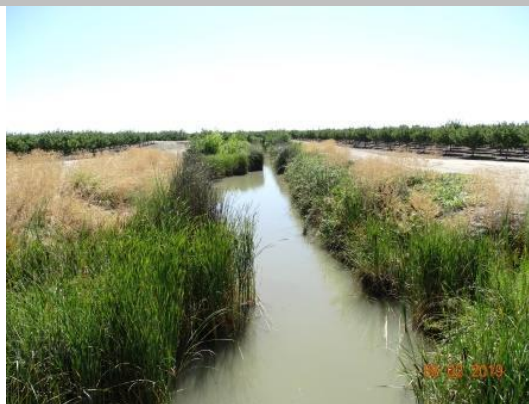
Photo 1 of 3 : CH\_2019\_NA0013\_36\_61\_20190814\_00095.jpg

Rating **	A	Issue No.	61	GPS Lat/Long
Issue Type +	Ma	Location *		37.269380 °
Category	Rivers, Channels & Designated Flood			-120.397470 °
Item	Vegetation & Obstructions			
DWR ID	DWR_NA0013_36_c_2014_61			
Action/Comments

View of vegetation in the channel. Summer 2019

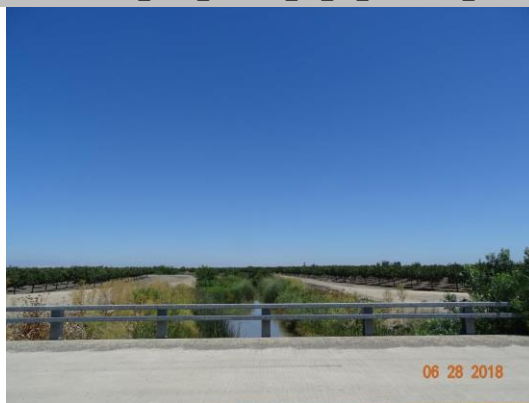
Photo 2 of 3 : CH\_2019\_NA0013\_36\_61\_20190722\_00030.jpg

Rating **	A	Issue No.	61 (cont)	GPS Lat/Long
Issue Type +	Ma	Location *		37.269380 °
Category	Rivers, Channels & Designated Flood			-120.397470 °
Item	Vegetation & Obstructions			
DWR ID	DWR_NA0013_36_c_2014_61			
Action/Comments

View of vegetation in the channel. Summer 2018

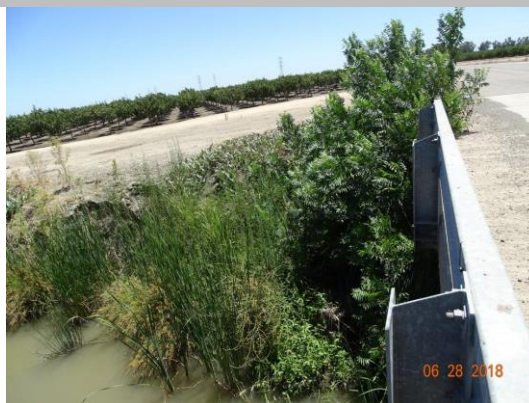
Photo 3 of 3 : CH\_2019\_NA0013\_36\_61\_20190722\_00031.jpg

Rating **	A	Issue No.	61 (cont)	GPS Lat/Long
Issue Type +	Ma	Location *		37.269380 °
Category	Rivers, Channels & Designated Flood			-120.397470 °
Item	Vegetation & Obstructions			
DWR ID	DWR_NA0013_36_c_2014_61			
Action/Comments

View of vegetation encroaching onto bridge. Summer 2018

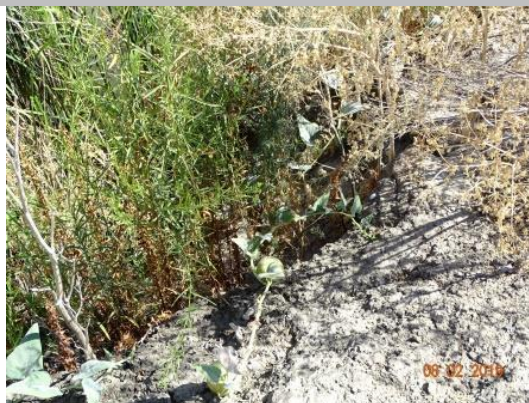
Photo 1 of 2 : CH\_2019\_NA0013\_36\_63\_20190814\_00096.jpg

Rating **	M	Issue No.	63	GPS Lat/Long
Issue Type +	Ma	Location *		37.269380 °
Category	Rivers, Channels & Designated Flood			-120.397470 °
Item	Erosion / Bank Caving			
DWR ID	DWR_NA0013_36_c_2012_63			
Action/Comments				
Inspector Comments: Erosion on the left bank does not appear to endanger the channel but may start impacting the adjacent farm road.

View of the erosion on the left bank. Summer 2019

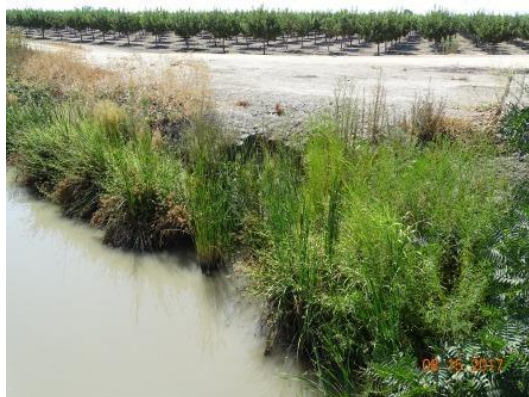
Photo 2 of 2 : CH\_2019\_NA0013\_36\_63\_20190722\_00033.jpg

View of the erosion in the channel. Summer 2017

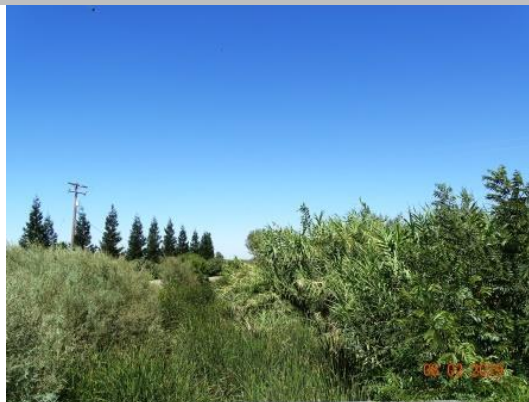
Photo 1 of 3 : CH\_2019\_NA0013\_36\_66\_20190814\_00097.jpg

Rating **	U	Issue No.	66	GPS Lat/Long
Issue Type +	Ma	Location *		37.269380 °
Category	Rivers, Channels & Designated Flood			-120.397470 °
Item	Vegetation & Obstructions			
DWR ID	DWR_NA0013_36_c_2012_66			
Action/Comments				
Inspector Comments: Excessive vegetation and arundo may impede flow and should be cleared at least 100 feet downstream.

View of vegetation in the channel and Arundo on the right bank.  
Summer 2019

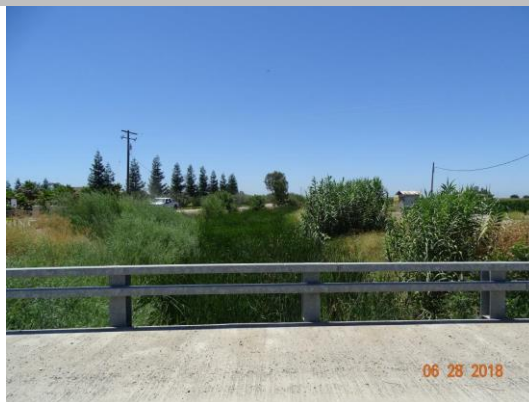
Photo 2 of 3 : CH\_2019\_NA0013\_36\_66\_20190722\_00034.jpg

Inspector Comments: Excessive vegetation and arundo may impede flow and should be cleared at least 100 feet downstream.

View of vegetation in the channel and Arundo on the right bank.  
Summer 2018

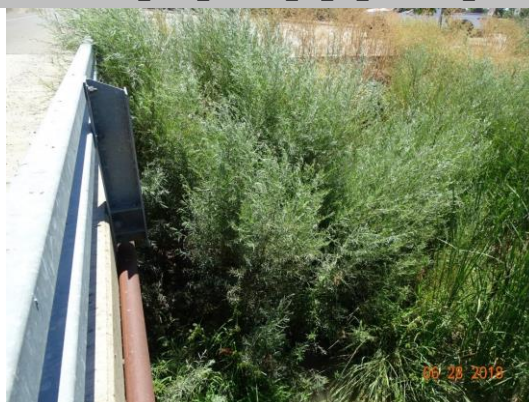
Photo 3 of 3 : CH\_2019\_NA0013\_36\_66\_20190722\_00035.jpg

View of vegetation adjacent to the bridge. Summer 2018

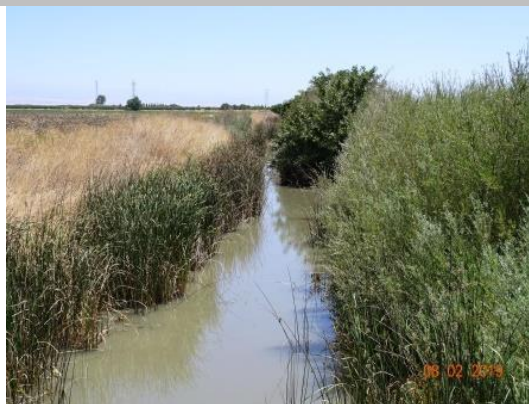
Photo 1 of 2 : CH\_2019\_NA0013\_36\_111\_20190814\_00098.jpg

View of vegetation in the channel. Summer 2019

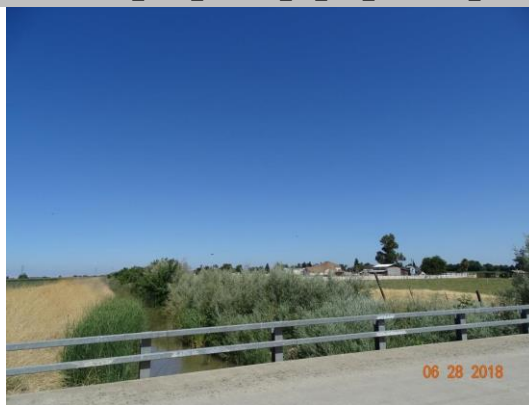
Photo 2 of 2 : CH\_2019\_NA0013\_36\_111\_20190722\_00062.jpg

View of vegetation in the channel. Summer 2018

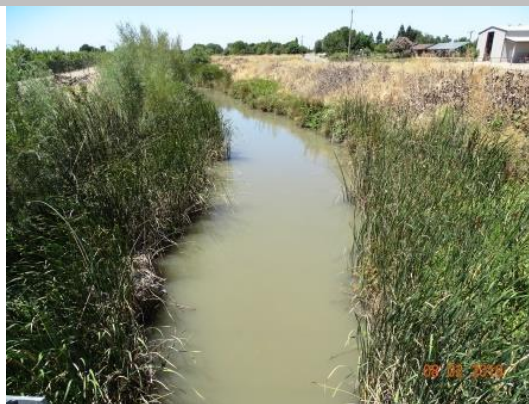
Photo 1 of 2 : CH\_2019\_NA0013\_36\_116\_20190814\_00099.jpg

View of vegetation in the channel. Summer 2019

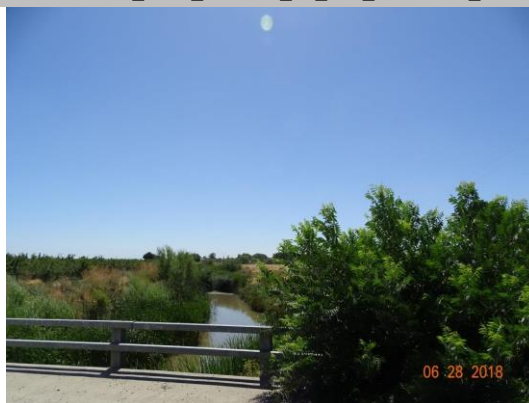
Photo 2 of 2 : CH\_2019\_NA0013\_36\_116\_20190722\_00065.jpg

View of vegetation in the channel. Summer 2018

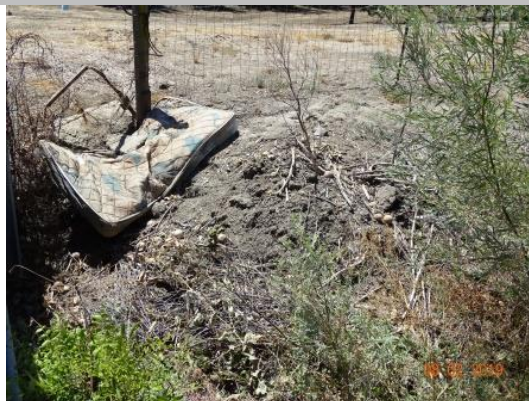
Photo 1 of 1 : CH\_2019\_NA0013\_36\_120\_20190814\_00100.jpg

View of mattress on left bank. Summer 2019

Rating **	A	Issue No.	120	GPS Lat/Long
Issue Type +	Ma	Location *		37.267270 °
Category	Rivers, Channels & Designated Flood			-120.415340 °
Item	Encroachments			
DWR ID	DWR_NA0013_36_c_2013_120			
Action/Comments				
Inspector Comments: Remove mattress from the left bank.

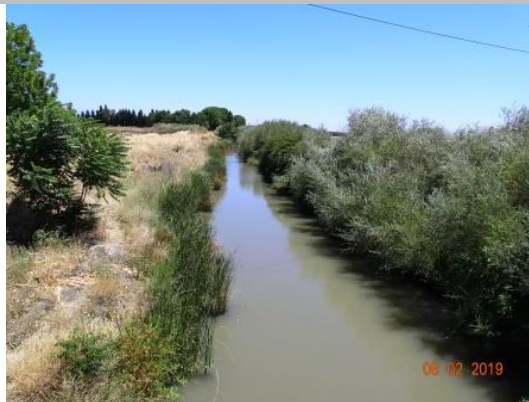
Photo 1 of 2 : CH\_2019\_NA0013\_36\_121\_20190814\_00101.jpg

View of vegetation in the channel. Summer 2019

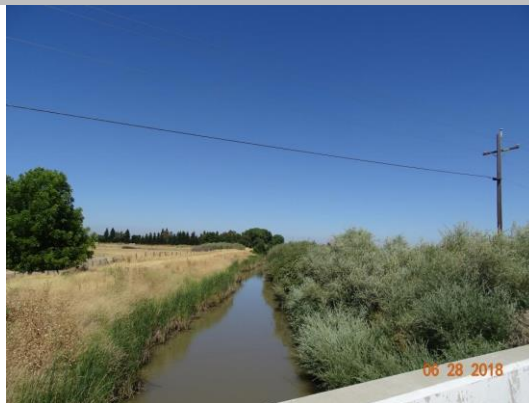
Photo 2 of 2 : CH\_2019\_NA0013\_36\_121\_20190722\_00068.jpg

View of vegetation in the channel. Summer 2018

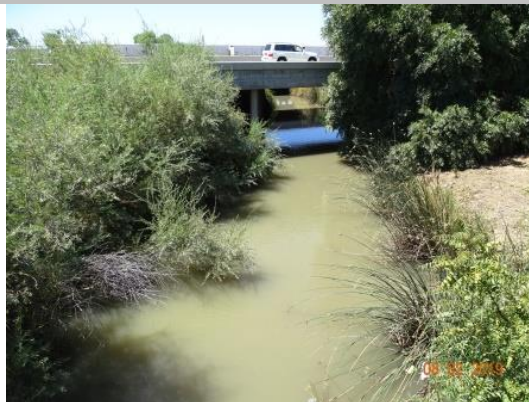
Photo 1 of 1 : CH\_2019\_NA0013\_36\_126\_20190814\_00102.jpg

Rating **	M	Issue No.	126	GPS Lat/Long
Issue Type +	Ma	Location *		37.265040 °
Category	Rivers, Channels & Designated Flood			-120.427410 °
Item	Vegetation & Obstructions			
DWR ID	DWR_NA0013_36_c_2013_126			
Action/Comments				
Inspector Comments: Woody vegetation on the left bank may impede flow in the future and should be controlled.

View of vegetation along the channel. Summer 2019

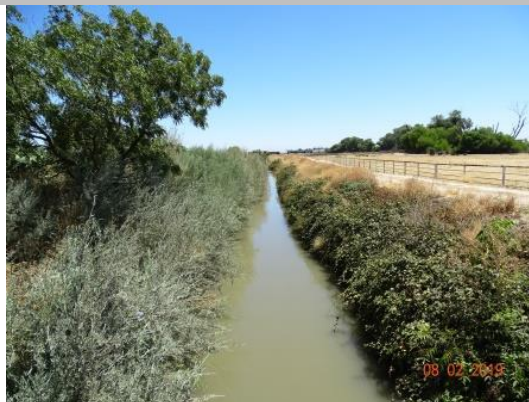
Photo 1 of 2 : CH\_2019\_NA0013\_36\_71\_20190814\_00103.jpg

Rating **	M	Issue No.	71	GPS Lat/Long
Issue Type +	Ma	Location *		37.263590 °
Category	Rivers, Channels & Designated Flood			-120.434500 °
Item	Vegetation & Obstructions			
DWR ID	DWR_NA0013_36_c_2012_71			
Action/Comments				
Inspector Comments: Woody vegetation in the channel may impede flow and should be cleared at least 100 feet upstream.

View of vegetation in the channel. Summer 2019

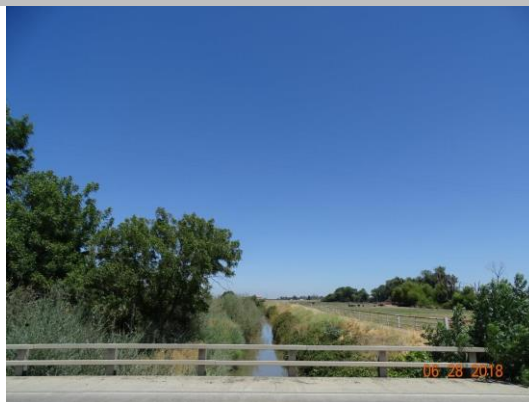
Photo 2 of 2 : CH\_2019\_NA0013\_36\_71\_20190722\_00037.jpg

Inspector Comments: Woody vegetation in the channel may impede flow and should be cleared at least 100 feet upstream.

View of vegetation in the channel and growth onto bridge. Summer 2018

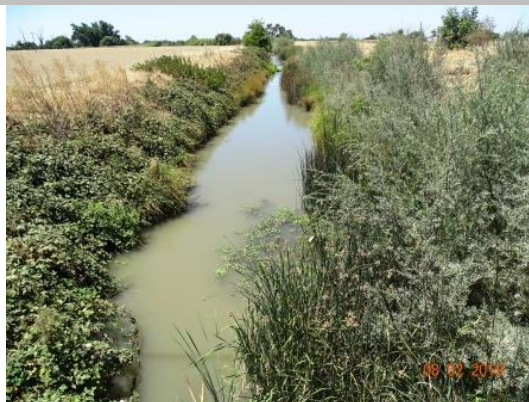
Photo 1 of 2 : CH\_2019\_NA0013\_36\_76\_20190814\_00104.jpg

View of vegetation in the channel. Summer 2019

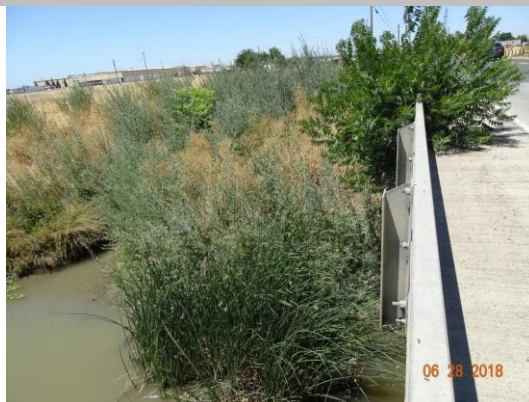
Photo 2 of 2 : CH\_2019\_NA0013\_36\_76\_20190722\_00040.jpg

View of vegetation in the channel and on the bridge. Summer 2018

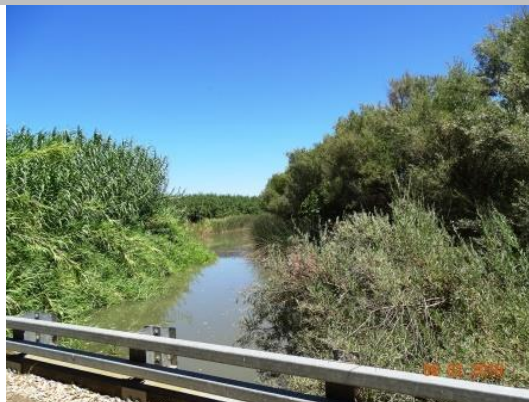
Photo 1 of 2 : CH\_2019\_NA0013\_36\_81\_20190814\_00105.jpg

Rating **	M	Issue No.	81	GPS Lat/Long
Issue Type +	Ma	Location *		37.263560 °
Category	Rivers, Channels & Designated Flood			-120.469660 °
Item	Vegetation & Obstructions			
DWR ID	DWR_NA0013_36_c_2012_81			
Action/Comments				
Inspector Comments: Woody vegetation at bridge and Arundo need to be removed.

View of vegetation along the channel. Summer 2019

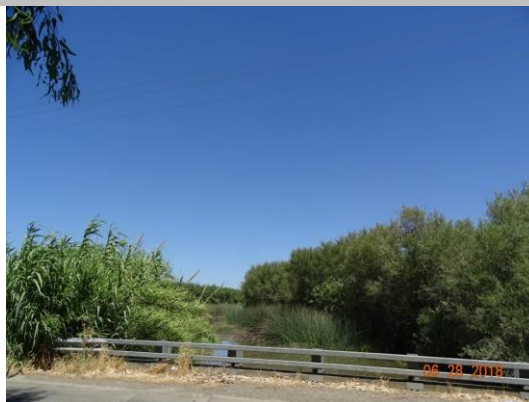
Photo 2 of 2 : CH\_2019\_NA0013\_36\_81\_20190722\_00042.jpg

Inspector Comments: Woody vegetation at bridge and Arundo need to be removed.

View of vegetation along the channel. Summer 2018

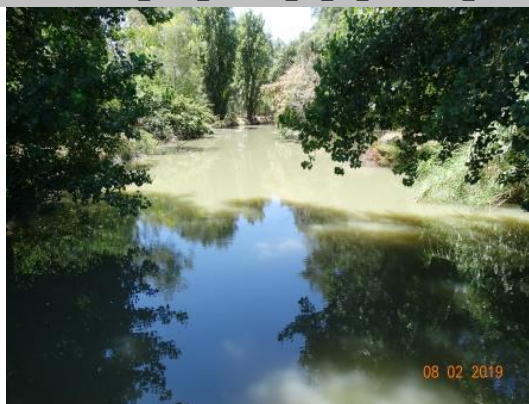
Photo 1 of 2 : CH\_2019\_NA0013\_36\_86\_20190814\_00106.jpg

View of vegetation along the channel. Summer 2019

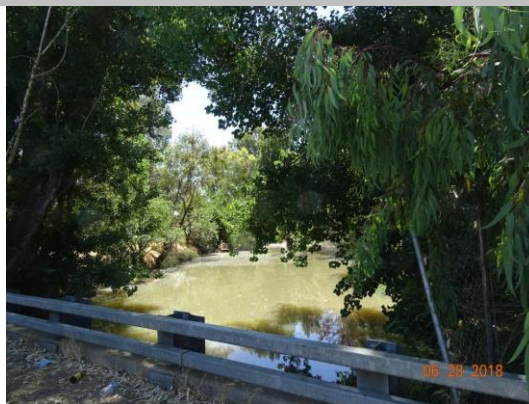
Photo 2 of 2 : CH\_2019\_NA0013\_36\_86\_20190722\_00045.jpg

View of vegetation along the channel. Summer 2018

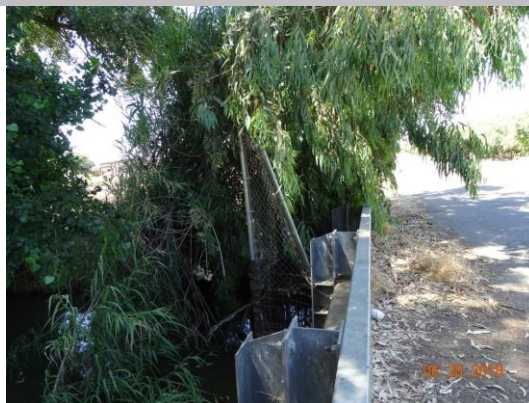
Photo 2 of 2 : CH\_2019\_NA0013\_36\_90\_20190722\_00048.jpg

Rating **	U	Issue No.	90	GPS Lat/Long
Issue Type +	En	Location *		37.263560 °
Category	Rivers, Channels & Designated Flood			-120.469660 °
Item	Encroachments			
DWR ID	DWR_NA0013_36_c_2012_90			
Action/Comments				
Inspector Comments: Wire fence encroaching channel by 11 feet on both sides. It may accumulate debris and restrict flow. Recommend removal of the lower part of the fence just below the bridge superstructure.

View of wire fencing on right bank. Summer 2018

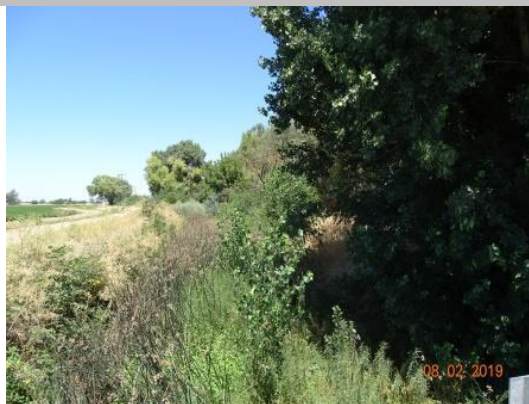
Photo 1 of 2 : CH\_2019\_NA0013\_36\_91\_20190814\_00107.jpg

View of vegetation in the channel. Summer 2019

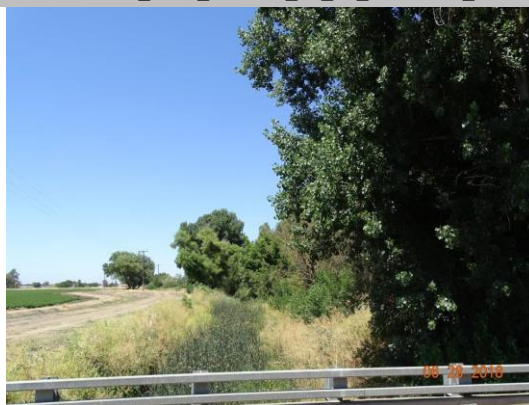
Photo 2 of 2 : CH\_2019\_NA0013\_36\_91\_20190722\_00049.jpg

View of vegetation in the channel. Summer 2018

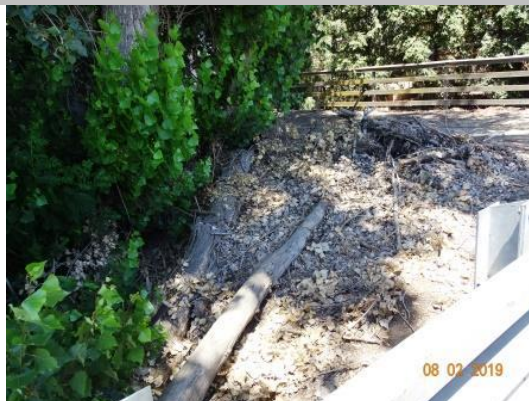
Photo 1 of 1 : CH\_2019\_NA0013\_36\_95\_20190814\_00108.jpg

View of tree log and prunings on the left bank. Summer 2019

Rating **	M	Issue No.	95	GPS Lat/Long
Issue Type +	En	Location *		37.258252 °
Category	Rivers, Channels & Designated Flood			-120.475230 °
Item	Encroachments			
DWR ID	DWR_NA0013_36_c_2012_95			
Action/Comments				
Inspector Comments: Prunings and tree logs need to be removed from left bank.

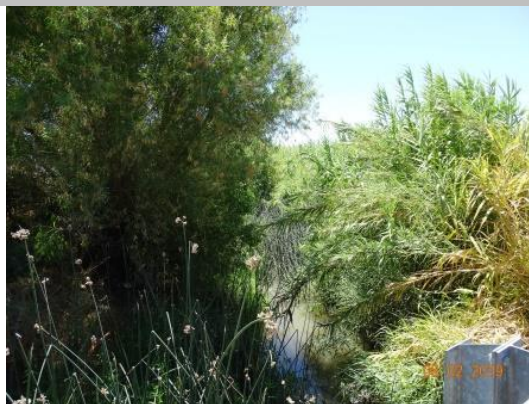
Photo 1 of 2 : CH\_2019\_NA0013\_36\_96\_20190814\_00109.jpg

View of vegetation in the channel. Summer 2019

Rating **	U	Issue No.	96	GPS Lat/Long
Issue Type +	Ma	Location *		37.257780 °
Category	Rivers, Channels & Designated Flood			-120.475090 °
Item	Vegetation & Obstructions			
DWR ID	DWR_NA0013_36_c_2012_96			
Action/Comments				
Inspector Comments: Remove Arundo and woody vegetation from the channel that impede flows.

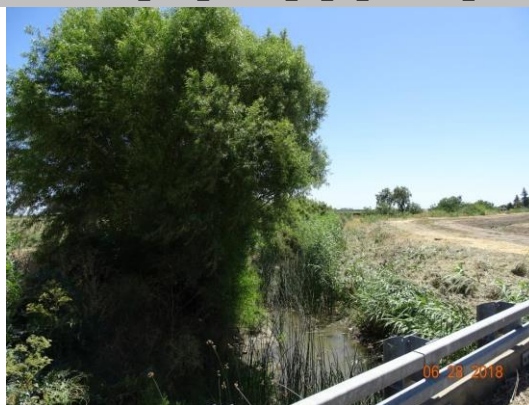
Photo 2 of 2 : CH\_2019\_NA0013\_36\_96\_20190722\_00051.jpg

View of vegetation in the channel. Summer 2018

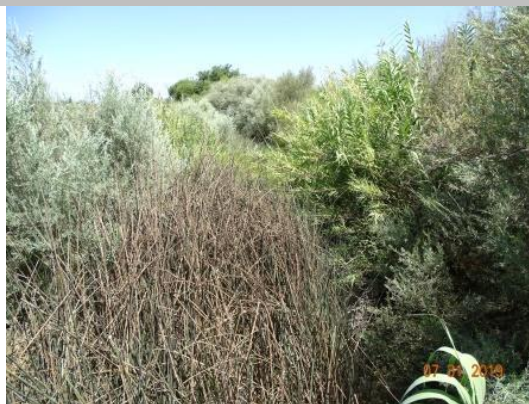
Photo 1 of 2 : CH\_2019\_NA0013\_36\_101\_20190809\_00073.jpg

Rating **	U	Issue No.	101	GPS Lat/Long
Issue Type +	Ma	Location *		37.255920 °
Category	Rivers, Channels & Designated Flood			-120.487940 °
Item	Vegetation & Obstructions			
DWR ID	DWR_NA0013_36_c_2012_101			
Action/Comments				
Inspector Comments: Woody vegetation and arundo in the channel may impede flow.

View of Arundo and woody vegetation upstream of the Hwy 59 crossing.  
Summer 2019

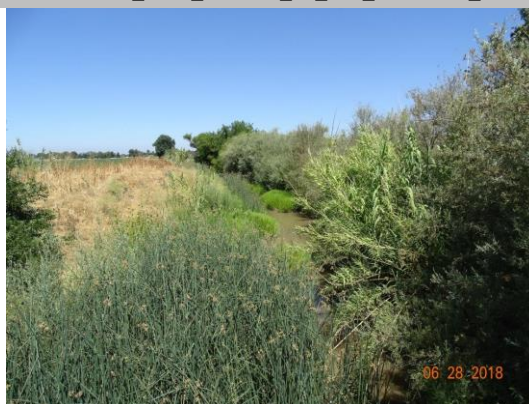
Photo 2 of 2 : CH\_2019\_NA0013\_36\_101\_20190722\_00054.jpg

Arundo and woody vegetation may impede flow and need to be cleared.  
Summer 2018

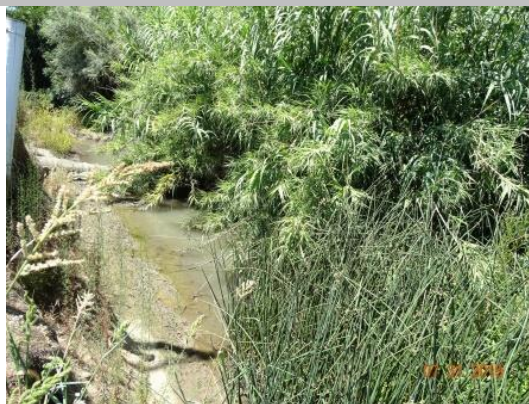
Photo 1 of 2 : CH\_2019\_NA0013\_36\_106\_20190809\_00074.jpg

View of vegetation downstream of the Hwy 59 crossing. Summer 2019

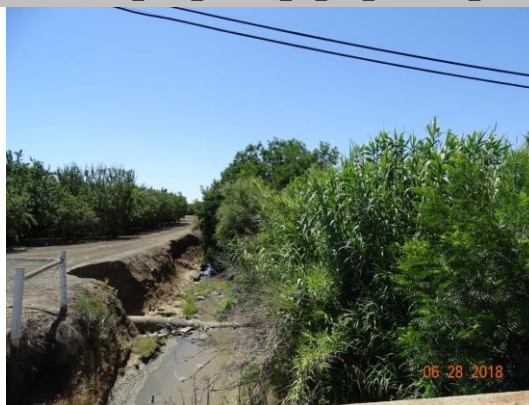
Photo 2 of 2 : CH\_2019\_NA0013\_36\_106\_20190722\_00057.jpg

View of Arundo and other woody vegetation in the channel. Summer 2018

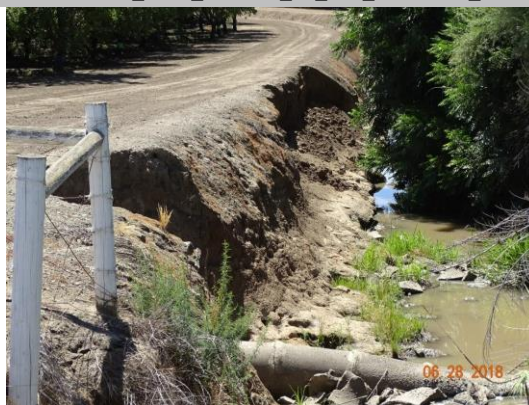
Photo 2 of 3 : CH\_2019\_NA0013\_36\_108\_20190722\_00059.jpg

Inspector Comments: Erosion on the left bank may be due to the pipe crossing and the overgrown woody vegetation on the right bank. The bank should be repaired, and the woody vegetation should be cleared.

View of erosion on the left bank. Summer 2018

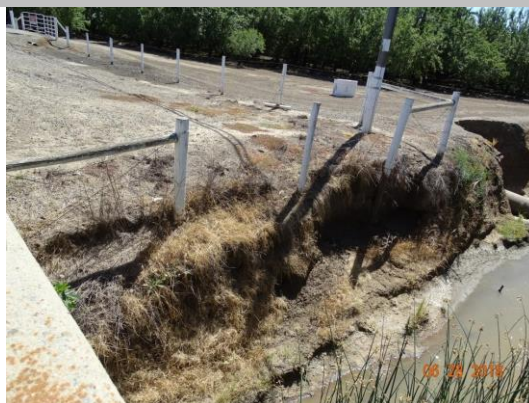
Photo 3 of 3 : CH\_2019\_NA0013\_36\_108\_20190722\_00060.jpg

View of erosion on the left bank. Summer 2018

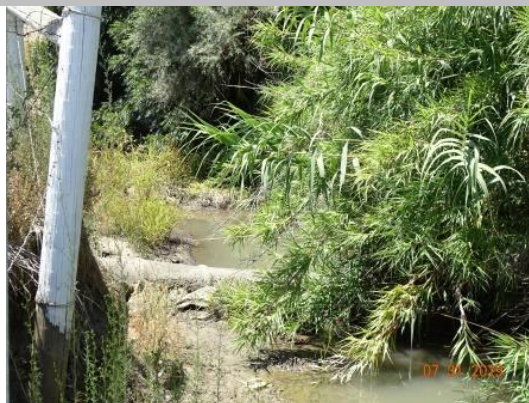
Photo 1 of 1 : CH\_2019\_NA0013\_36\_110\_20190809\_00076.jpg

Rating **	U	Issue No.	110	GPS Lat/Long
Issue Type +	En	Location *		37.255920 °
Category	Rivers, Channels & Designated Flood			-120.487940 °
Item	Encroachments			
DWR ID	DWR_NA0013_36_c_2012_110			
Action/Comments				
Inspector Comments: Major erosion is occurring around the pipe crossing, which does not appear to be authorized.

View of pipe crossing downstream of Hwy 59 bridge. Summer 2019

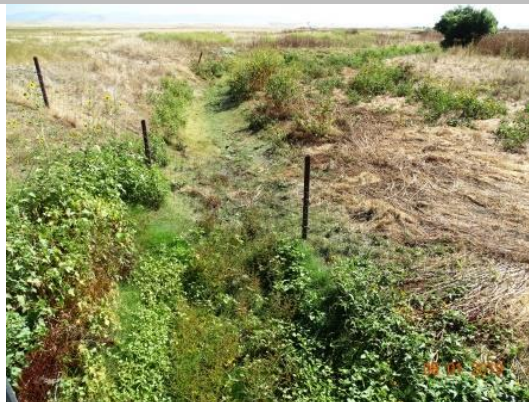
Photo 1 of 2 : CH\_2019\_NA0013\_37\_1\_20190809\_00033.jpg

View of vegetation upstream of Cunningham Road. Summer 2019

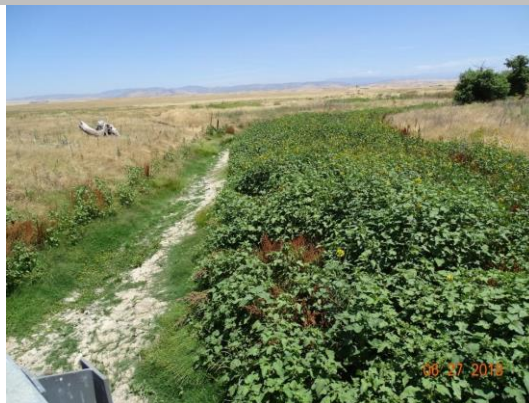
Photo 2 of 2 : CH\_2019\_NA0013\_37\_1\_20190722\_00001.jpg

View of growing vegetation in channel. Summer 2018

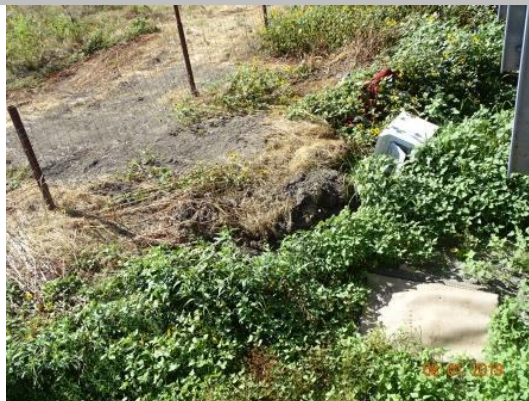
Photo 1 of 2 : CH\_2019\_NA0013\_37\_5\_20190809\_00035.jpg

Rating **	M	Issue No.	5	GPS Lat/Long
Issue Type +	Ma	Location *		37.290387 °
Category	Rivers, Channels & Designated Flood			-120.251840 °
Item	Encroachments			
DWR ID	DWR_NA0013_37_c_2012_5			
Action/Comments				
Inspector Comments: There is a wire fence with a pulley system to raise it during flood season. Remove washer and other debris from the channel.

View of washer and other debris upstream of Cunningham Road.  
Summer 2019

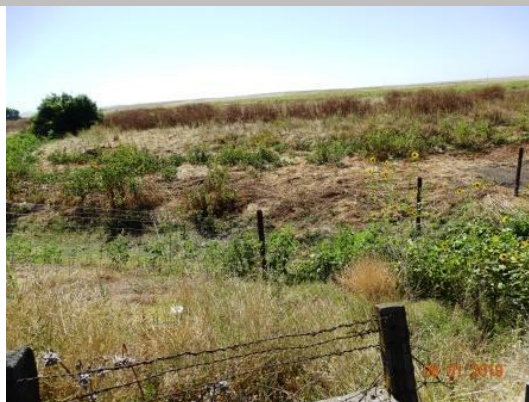
Photo 2 of 2 : CH\_2019\_NA0013\_37\_5\_20190809\_00034.jpg

Inspector Comments: There is a wire fence with a pulley system to raise it during flood season. Remove washer and other debris from the channel.

View of new, retractable wire fence across channel and old wire fence on the right bank. Summer 2019

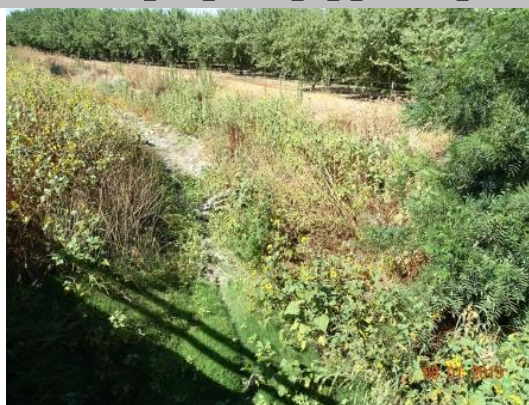
Photo 1 of 2 : CH\_2019\_NA0013\_37\_6\_20190809\_00036.jpg

Inspector Comments: Vegetation in channel should be maintained.

View of vegetation in the channel. Summer 2019

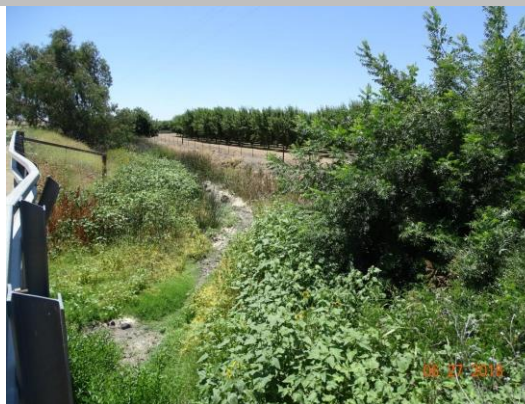
Photo 2 of 2 : CH\_2019\_NA0013\_37\_6\_20190722\_00003.jpg

Inspector Comments: Vegetation in channel should be maintained.

View of growing vegetation in channel. Summer 2018

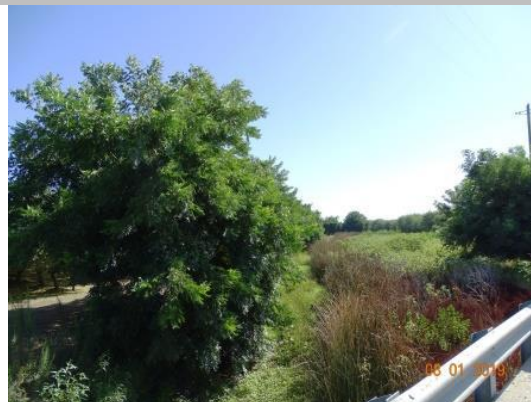
Photo 1 of 3 : CH\_2019\_NA0013\_37\_11\_20190809\_00028.jpg

Rating **	A	Issue No.	11	GPS Lat/Long
Issue Type +	Ma	Location *		37.287269 °
Category	Rivers, Channels & Designated Flood			-120.254914 °
Item	Vegetation & Obstructions			
DWR ID	DWR_NA0013_37_c_2012_11			
Action/Comments				
Inspector Comments: The fig tree growing underneath the bridge needs to be removed. The logs under the bridge from the previous inspection have been removed.

View of vegetation in the channel. Summer 2019

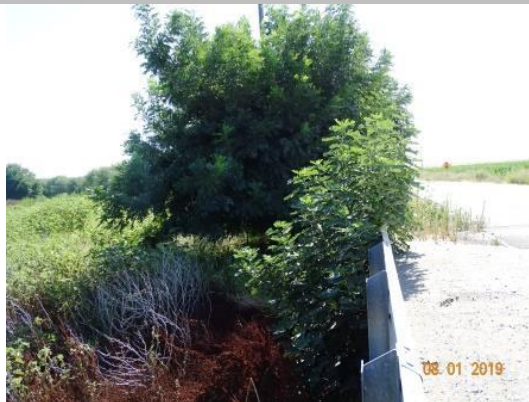
Photo 2 of 3 : CH\_2019\_NA0013\_37\_11\_20190809\_00030.jpg

Inspector Comments: The fig tree growing underneath the bridge needs to be removed. The logs under the bridge from the previous inspection have been removed.

View of fig tree growing underneath the bridge. Summer 2019

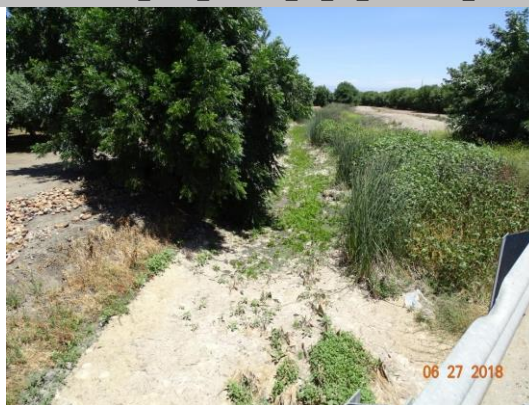
Photo 3 of 3 : CH\_2019\_NA0013\_37\_11\_20190722\_00005.jpg

View of vegetation in the channel. Summer 2018

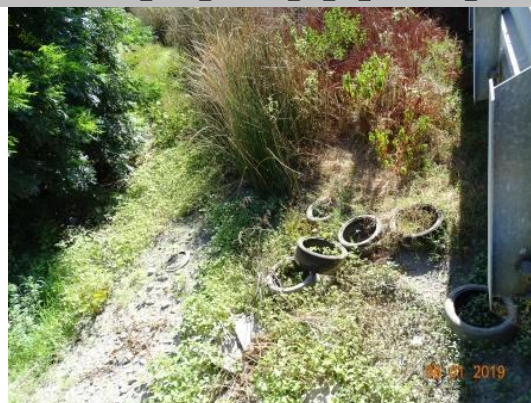
Photo 1 of 1 : CH\_2019\_NA0013\_37\_15\_20190809\_00029.jpg

Rating **	A	Issue No.	15	GPS Lat/Long
Issue Type +	Ma	Location *		37.287269 °
Category	Rivers, Channels & Designated Flood			-120.254914 °
Item	Encroachments			
DWR ID	DWR_NA0013_37_c_2012_15			
Action/Comments				
Inspector Comments: Remove tires from the channel.

View of tires in the channel. Summer 2019

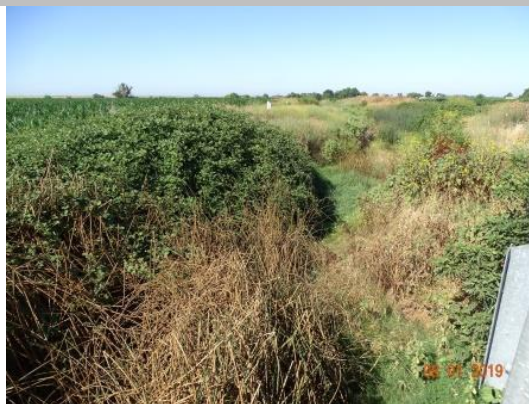
Photo 1 of 2 : CH\_2019\_NA0013\_37\_16\_20190809\_00031.jpg

Rating **	M	Issue No.	16	GPS Lat/Long
Issue Type +	Ma	Location *		37.287303 °
Category	Rivers, Channels & Designated Flood			-120.254863 °
Item	Vegetation & Obstructions			
DWR ID	DWR_NA0013_37_c_2012_16			
Action/Comments				
Inspector Comments: The vegetation in the channel may impede flows and needs to be controlled or removed.

View of vegetation in channel. Summer 2019

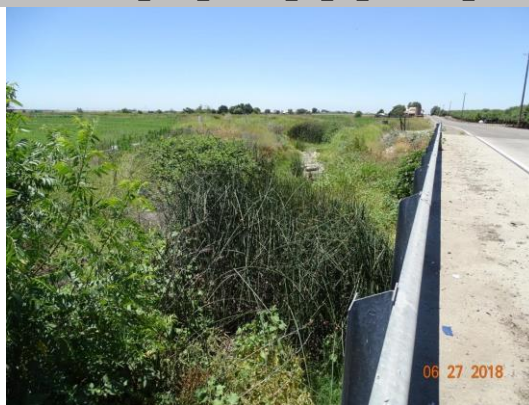
Photo 2 of 2 : CH\_2019\_NA0013\_37\_16\_20190722\_00008.jpg

Growing vegetation in channel. Summer 2018

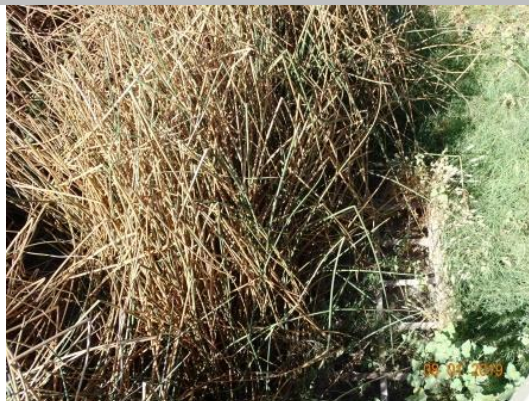
Photo 1 of 1 : CH\_2019\_NA0013\_37\_20\_20190809\_00032.jpg

Rating **	M	Issue No.	20	GPS Lat/Long
Issue Type +	Ma	Location *		37.287269 °
Category	Rivers, Channels & Designated Flood			-120.254914 °
Item	Encroachments			
DWR ID	DWR_NA0013_37_c_2012_20			
Action/Comments				
Inspector Comments: Remove tires and pallet from the channel.

View of pallet downstream of the bridge. Summer 2019

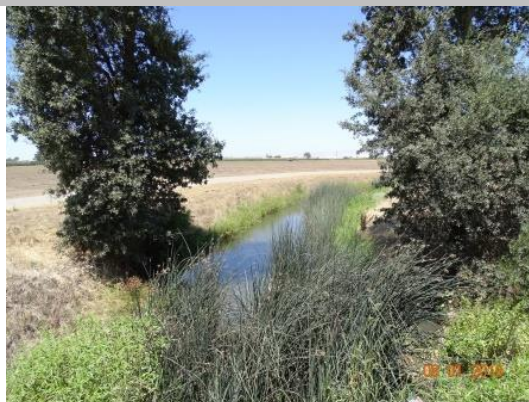
Photo 1 of 1 : CH\_2019\_NA0013\_37\_21\_20190813\_00037.jpg

View of vegetation in the channel. Summer 2019

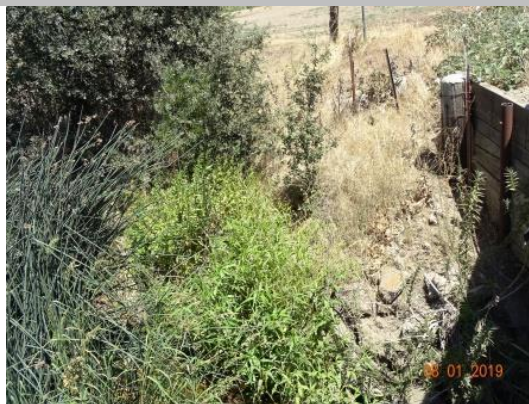
Photo 1 of 2 : CH\_2019\_NA0013\_37\_24\_20190813\_00038.jpg

View of riprap on left bank. Summer 2019

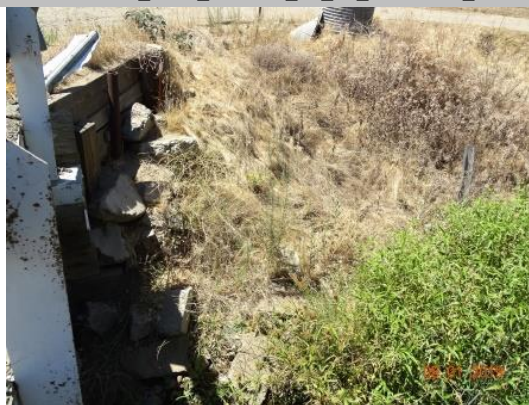
Photo 2 of 2 : CH\_2019\_NA0013\_37\_24\_20190813\_00039.jpg

View of riprap on right bank. Summer 2019

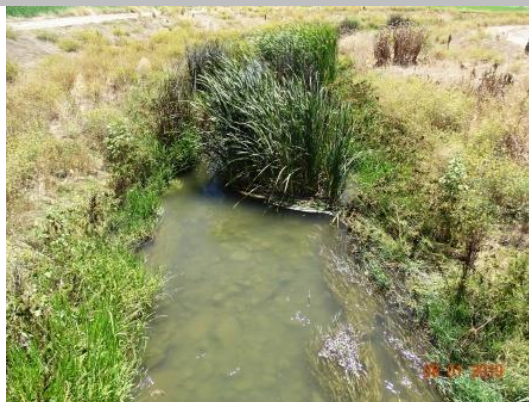
Photo 1 of 2 : CH\_2019\_NA0013\_37\_26\_20190813\_00040.jpg

View of vegetation in the channel. Summer 2019

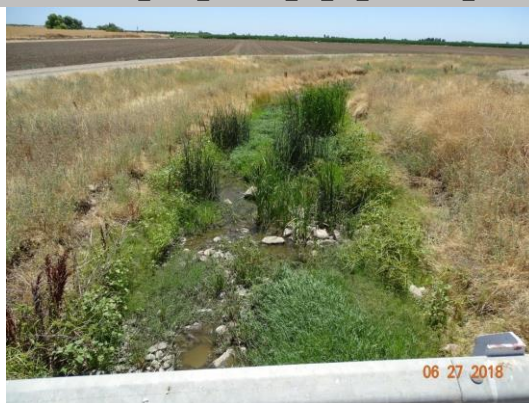
Photo 2 of 2 : CH\_2019\_NA0013\_37\_26\_20190722\_00015.jpg

View of growing vegetation in channel. Summer 2018

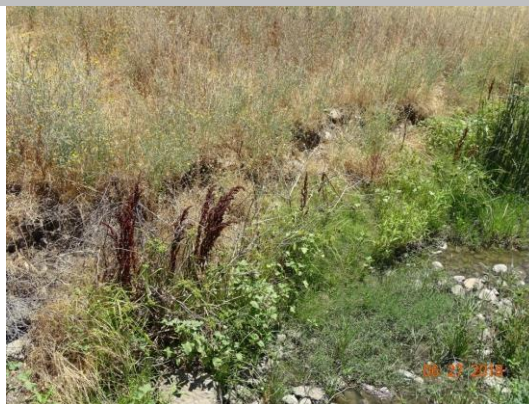
Photo 1 of 1 : CH\_2019\_NA0013\_37\_28\_20190722\_00017.jpg

View of minor erosion on left bank. Summer 2018

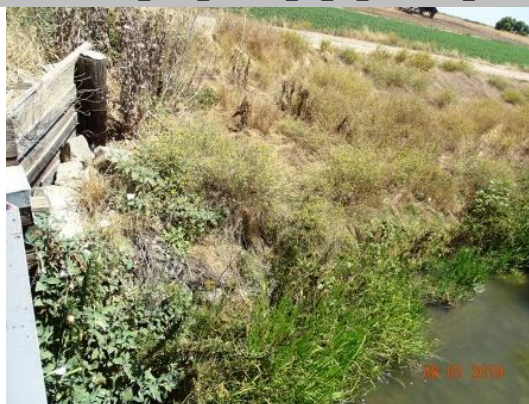
Photo 1 of 3 : CH\_2019\_NA0013\_37\_29\_20190813\_00041.jpg

View of riprap on left bank. Summer 2019

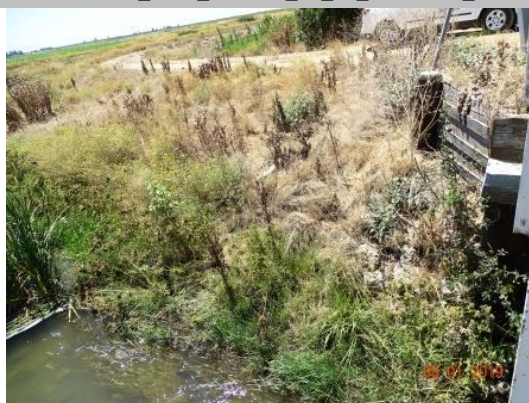
Photo 2 of 3 : CH\_2019\_NA0013\_37\_29\_20190813\_00042.jpg

View of riprap on right bank. Summer 2019

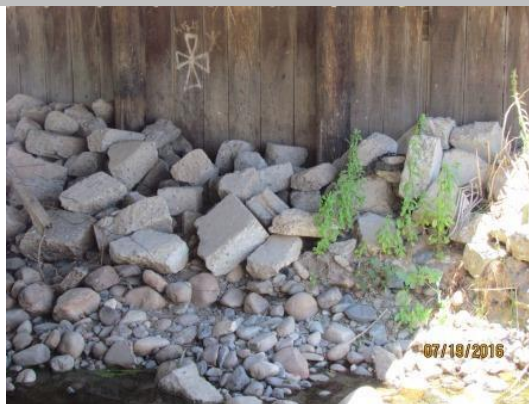
Photo 3 of 3 : CH\_2019\_NA0013\_37\_29\_20190722\_00020.jpg

View of the riprap in the channel at Mission Ave crossing. Summer 2017

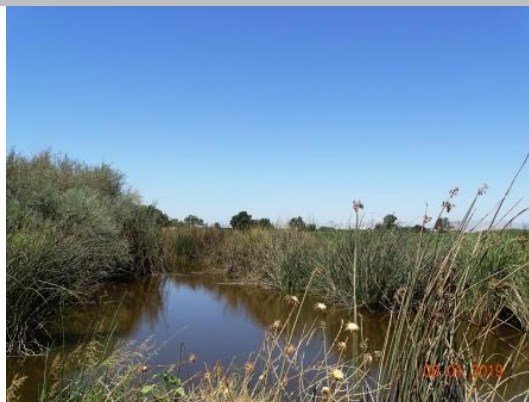
Photo 1 of 2 : CH\_2019\_NA0013\_37\_31\_20190813\_00043.jpg

View of vegetation in the channel looking upstream. Summer 2019

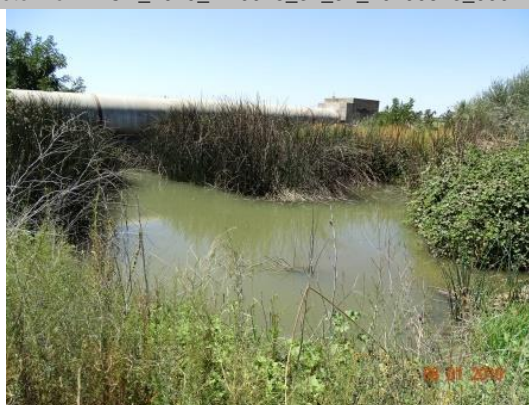
Photo 2 of 2 : CH\_2019\_NA0013\_37\_31\_20190813\_00044.jpg

View of vegetation in the channel looking downstream. Summer 2019

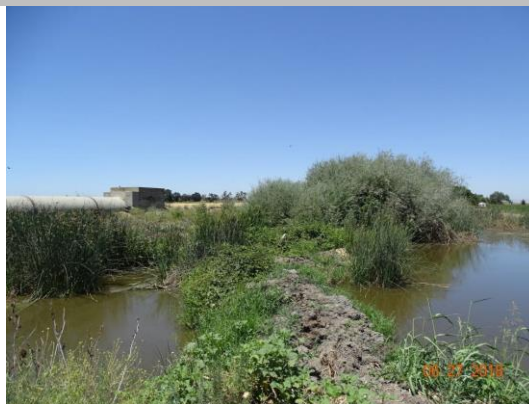
Photo 2 of 2 : CH\_2019\_NA0013\_37\_35\_20190722\_00024.jpg

Inspector Comments: A property owner placed a temporary earth dam across the channel, and there appears to be a beaver dam adjacent to it. The earth dam and beaver dam need to be removed during the flood season.

View of an earth dam placed across the channel. Summer 2018

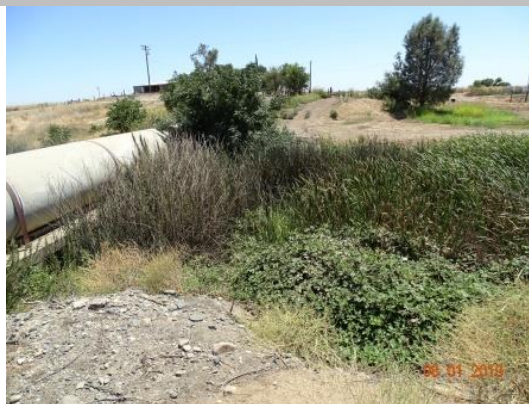
Photo 1 of 1 : CH\_2019\_NA0013\_37\_36\_20190813\_00046.jpg

Inspector Comments: Clear vegetation in the channel that may impede flows.

View of vegetation in the channel downstream of the diversion. Summer 2019
